**DOT/FAA/AR-96/21**

# **Composite Failure Analysis Handbook Update 1**

**WL-TR-93-4004**

August 1997

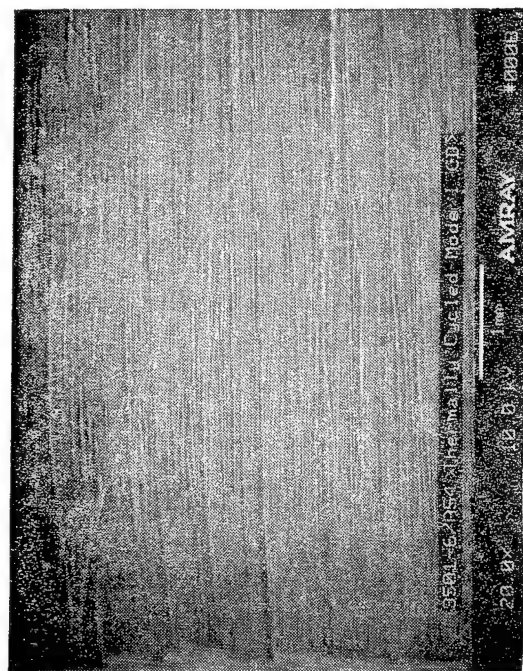
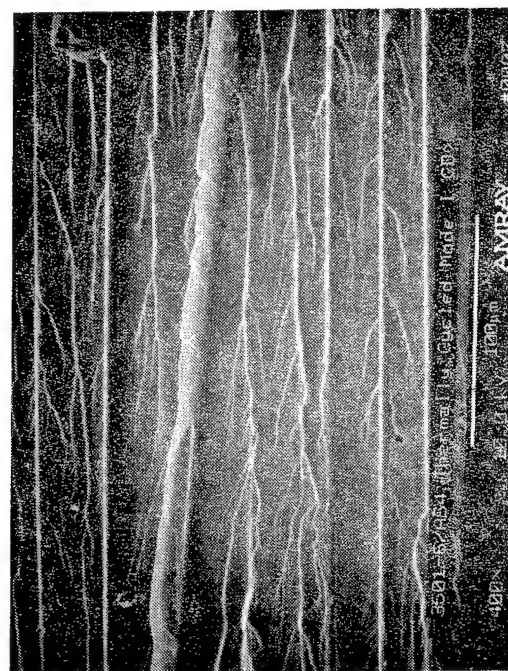
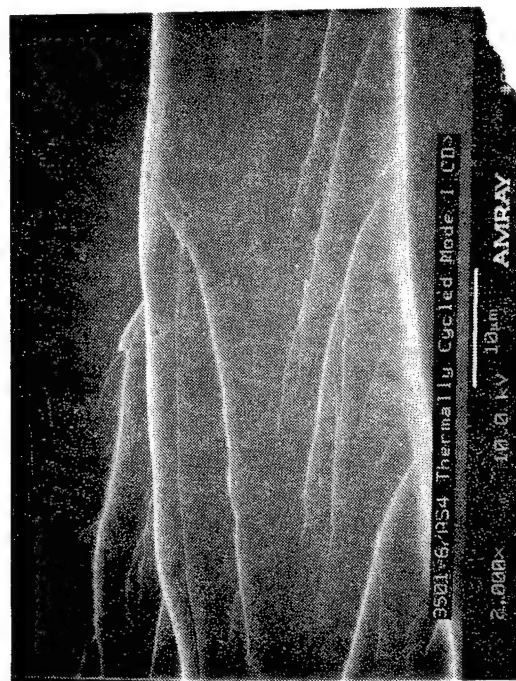
Figure 3.1-20. SEM Fractographs of a 3501-6/AS4 Interlaminar Mode I Tension Fracture Surface, Thermally Cycled

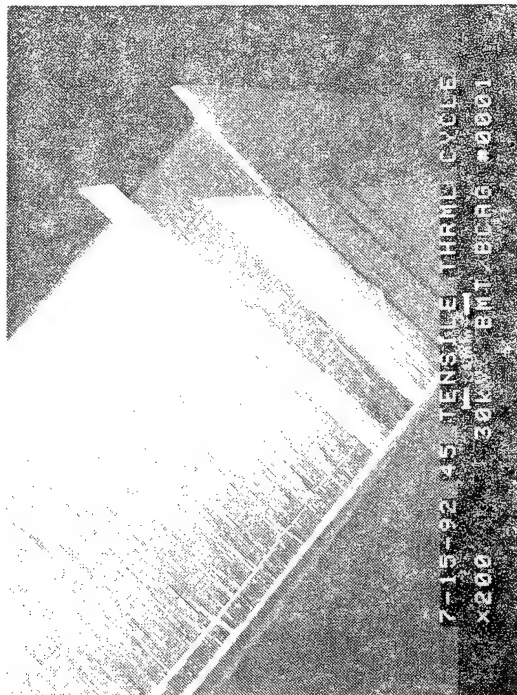
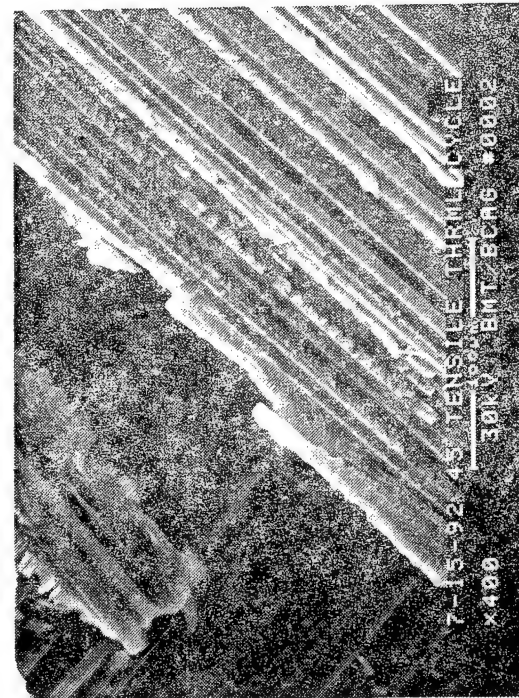
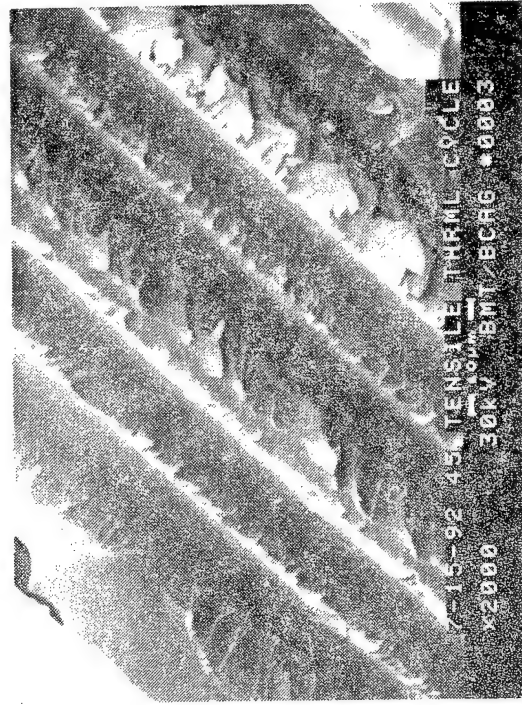
Figure 3.1-21. SEM Fractographs of a 3501-6/AS4 ± 45 Tensile Specimen Thermally Cycled, Interlaminar Surface

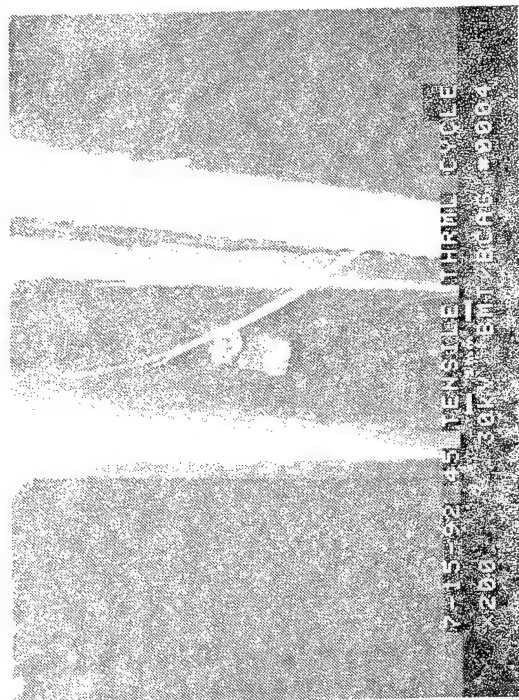
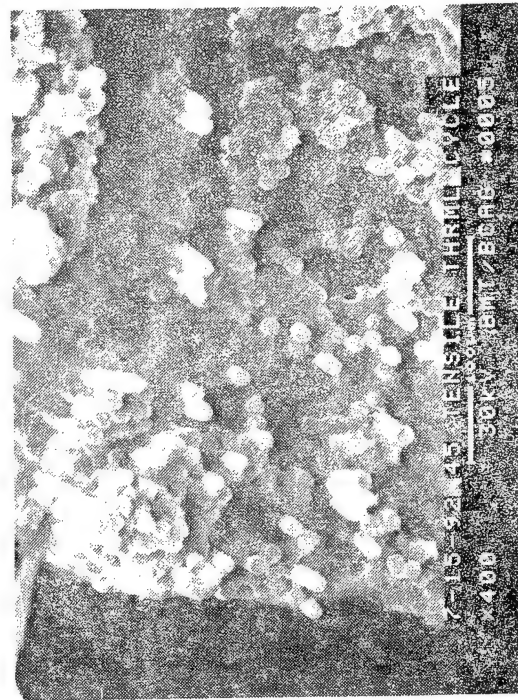
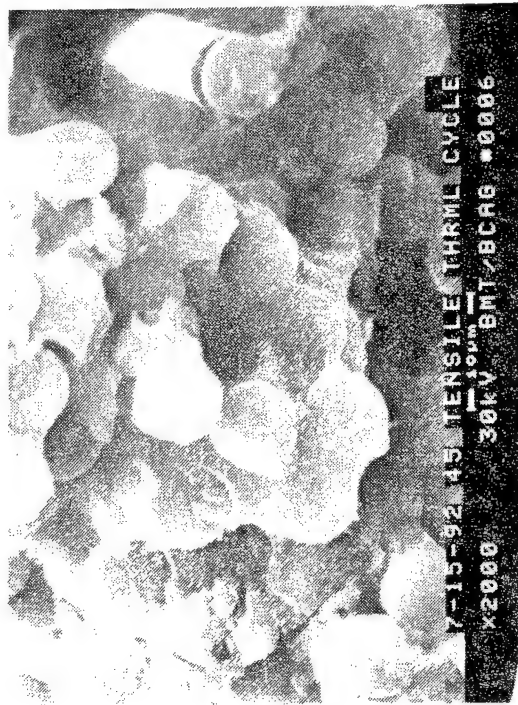
Figure 3.1-22. SEM Fractographs of a 3501-6/AS4  $\pm$  45 Tensile Specimen Thermally Cycled, Translaminar Surface

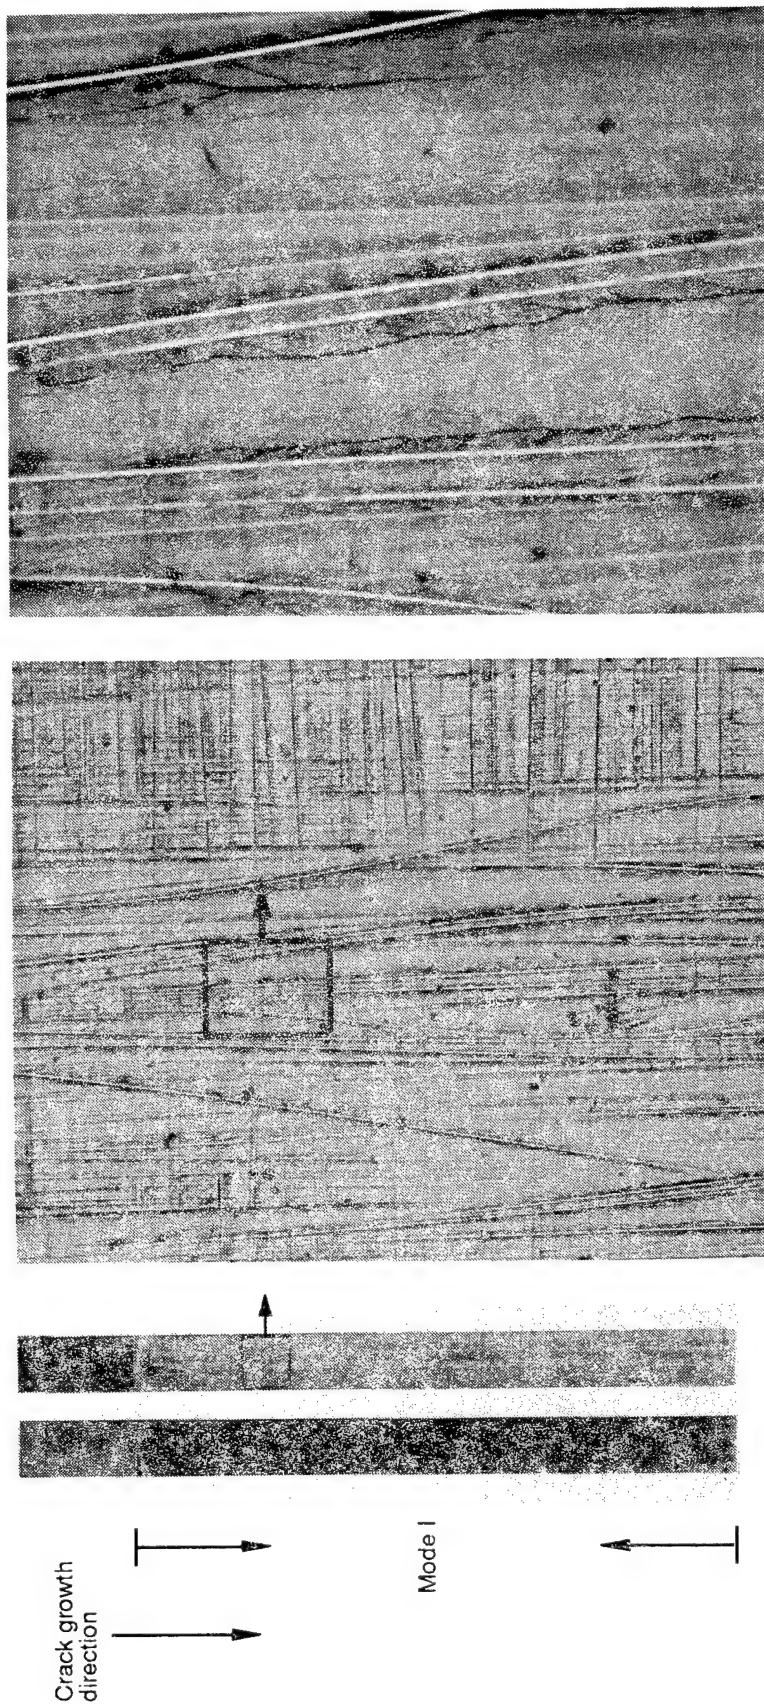
Figure 3.1-23. Optical Fractography of 3501-6/AS4 Interlaminar Mode I Tension Specimen, Moisture/Dryout Cycled

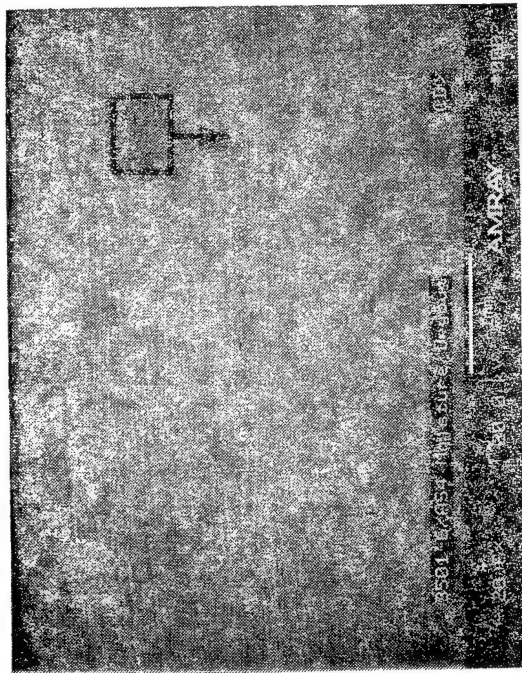
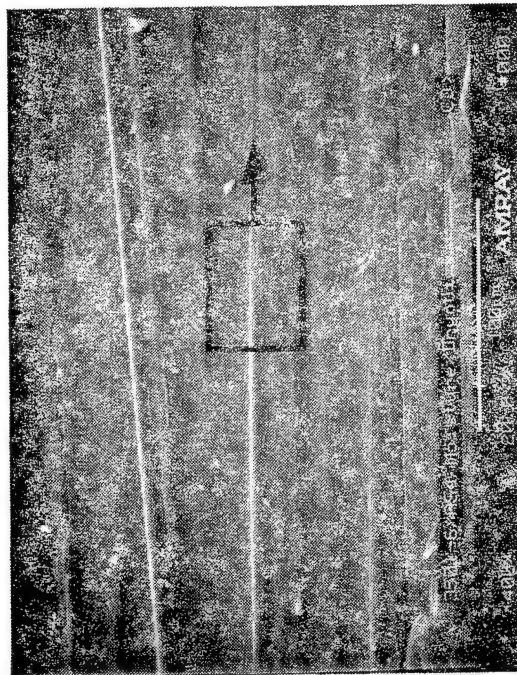
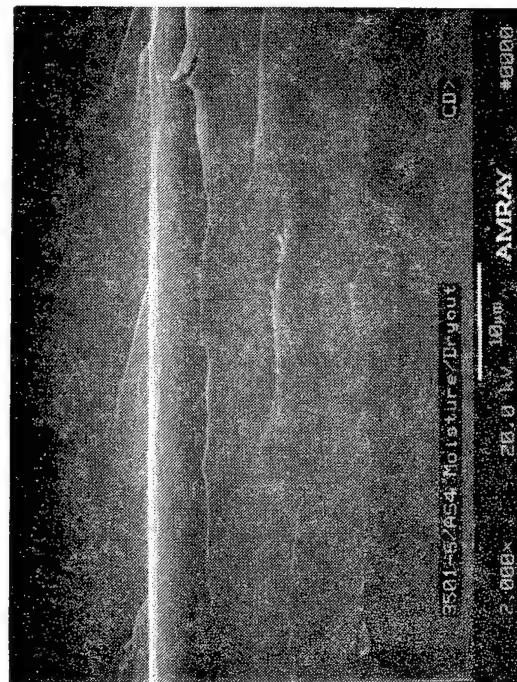
Figure 3.1-24. SEM Fractographs of a 3501-6/AS4 Interlaminar Mode I Tensile Fracture Surface Tested After Moisture/Dryout Cycling

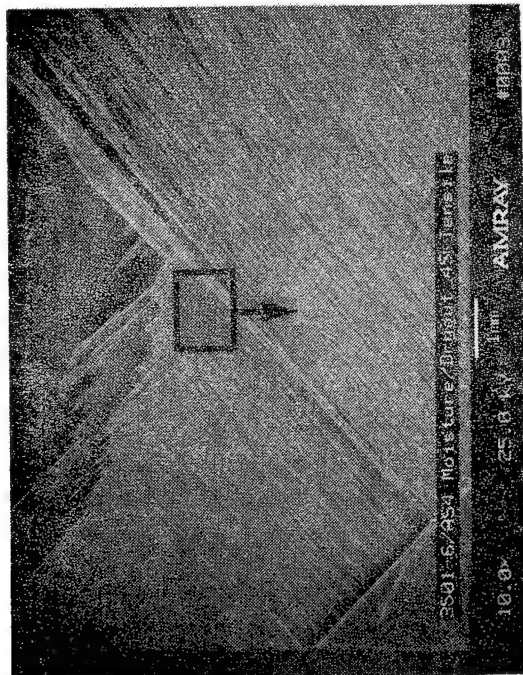
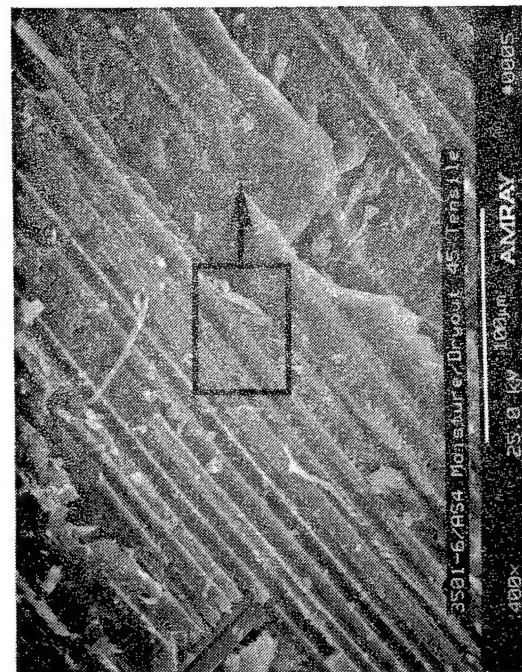
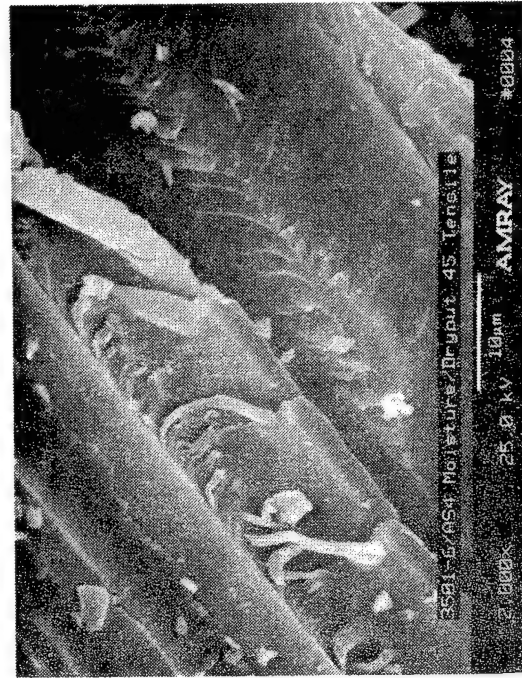
Figure 3.1-25. SEM Fractographs of a 3501-6/AS4  $\pm 45^\circ$  Tensile Specimen Tested After Moisture/Dryout Cycling, Interlaminar Surface

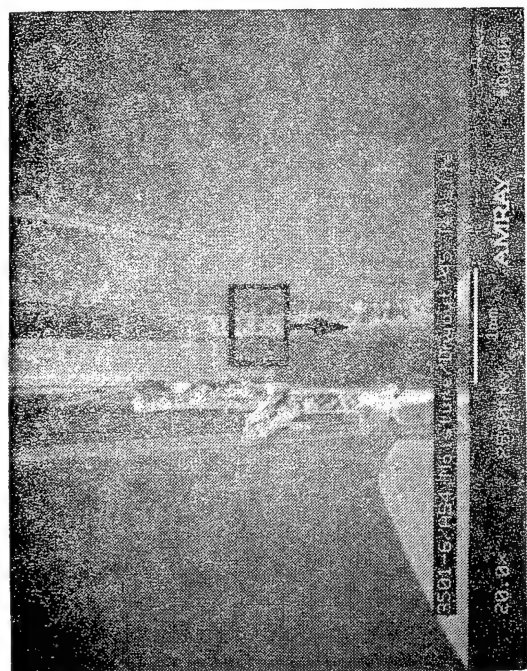
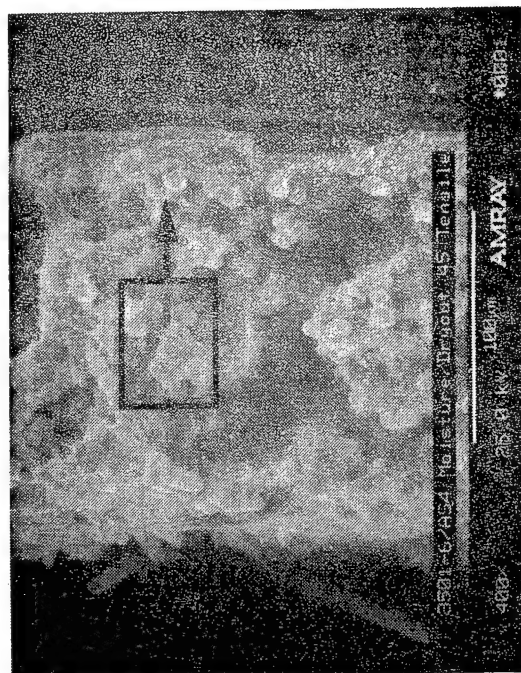
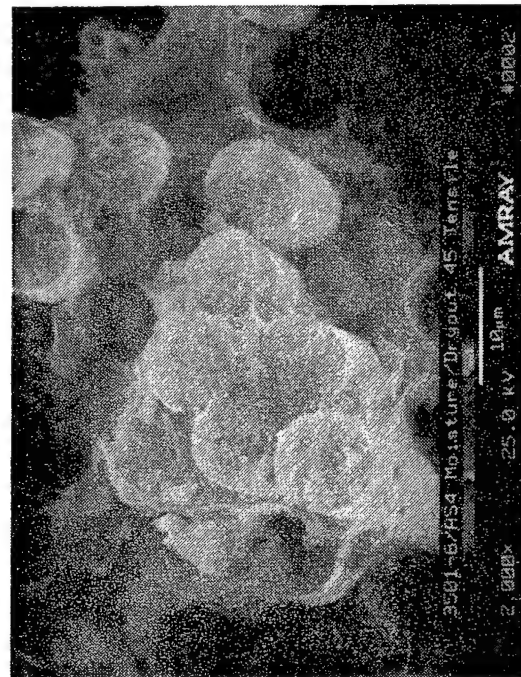
Figure 3.1-26. SEM Fractographs of a 3501-6/AS4  $\pm 45^\circ$  Tensile Specimen Tested After Moisture/Dryout Cycling, Translaminar Surface

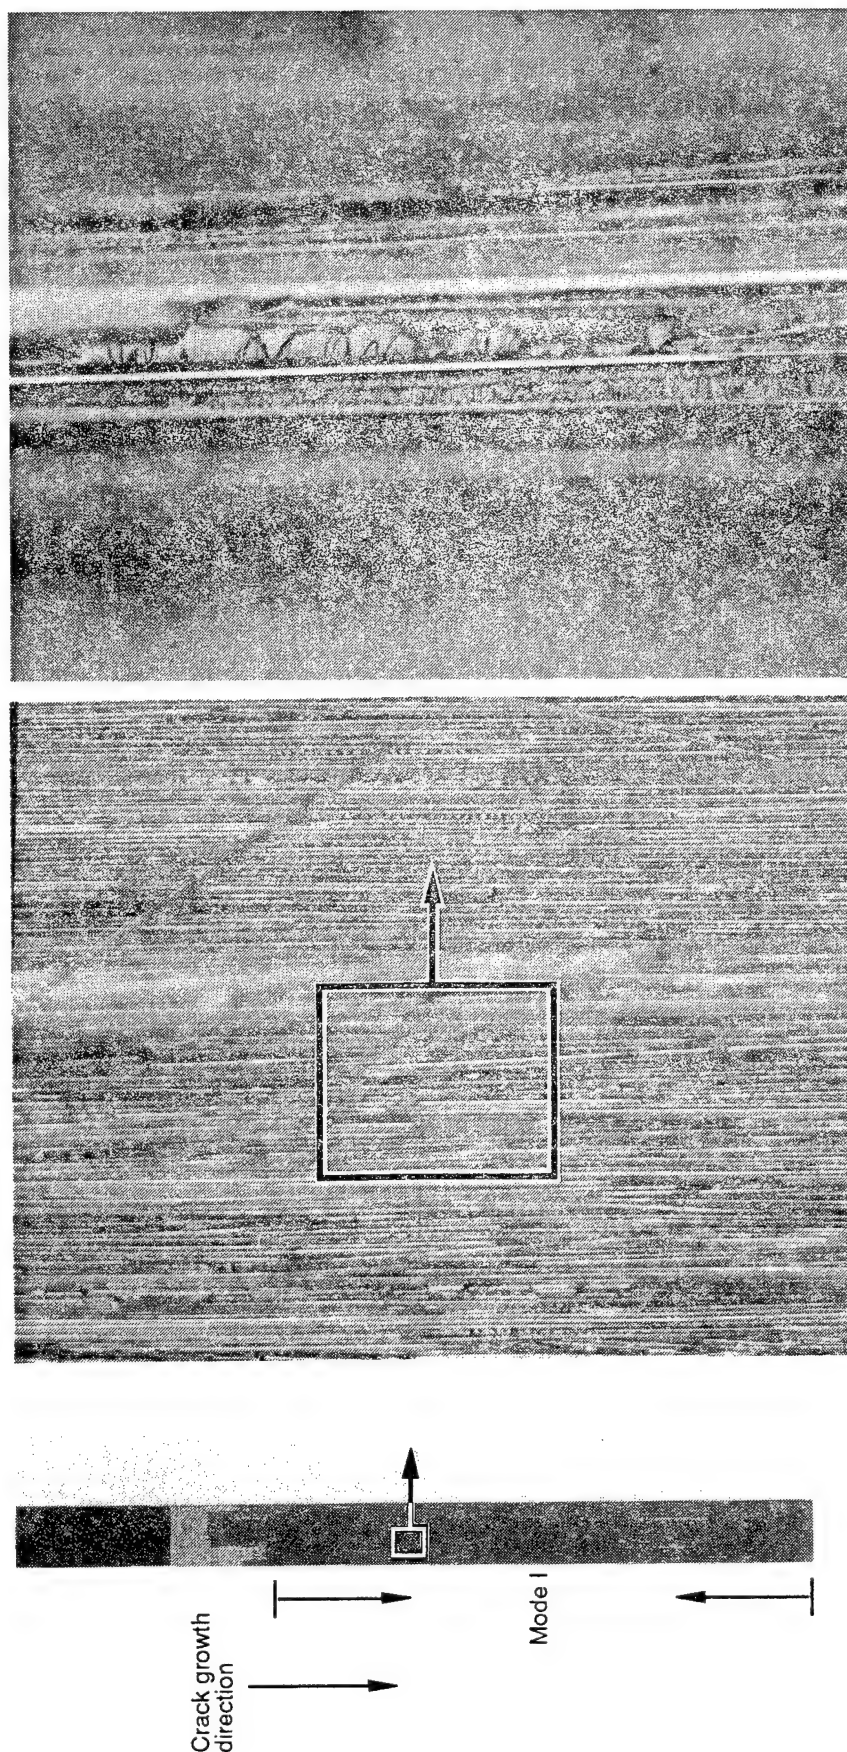
The fracture morphology of the specimens exhibited similar features as those of the PEEK material system, which is a true thermoplastic. On a macroscopic scale, numerous loose fibers were on the surface due to fiber pull-out. Microscopically, these features include the slow ductile peeling of the matrix craze filaments, which produce a limited river pattern and some cusps, which are generally associated with mode II (shear) loading (Figures 3.2-1 and 3.2-2).

Figure 3.2-1. Optical Fractography of KIIII/AS4 Interlaminar Mode I Tension Specimen Tested at RT/Dry

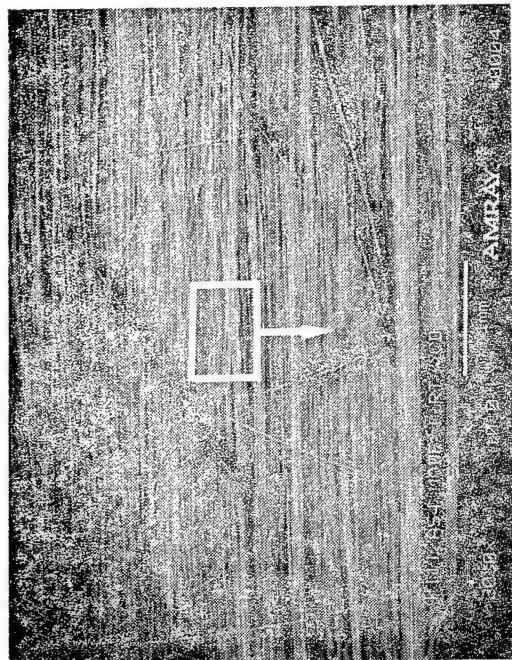
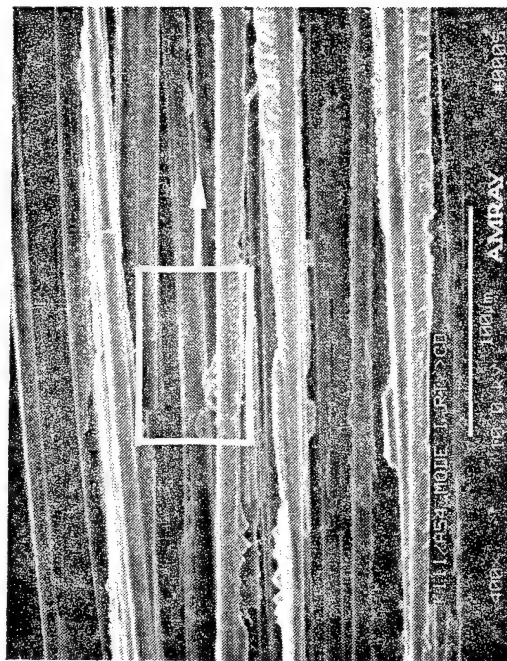
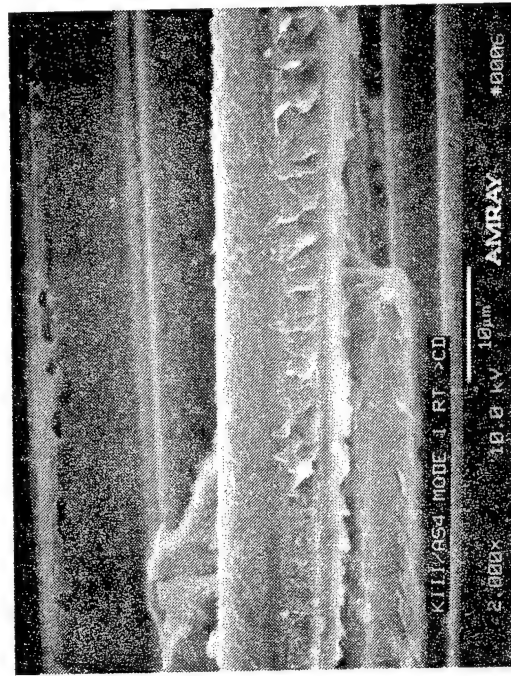
Figure 3.2-2. SEM Fractographs of a KIII/AS4 Interlaminar Mode I Shear Fracture Surface Tested at RT/Dry

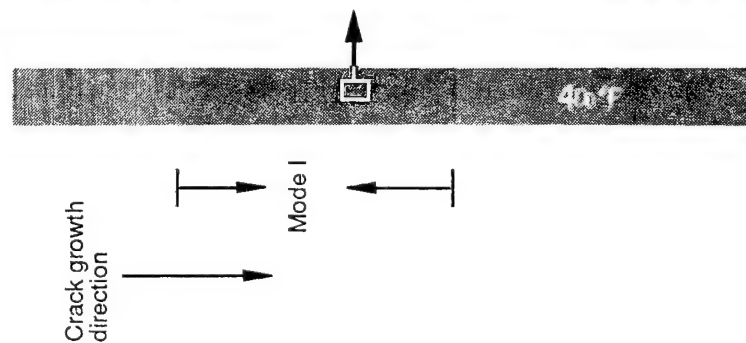
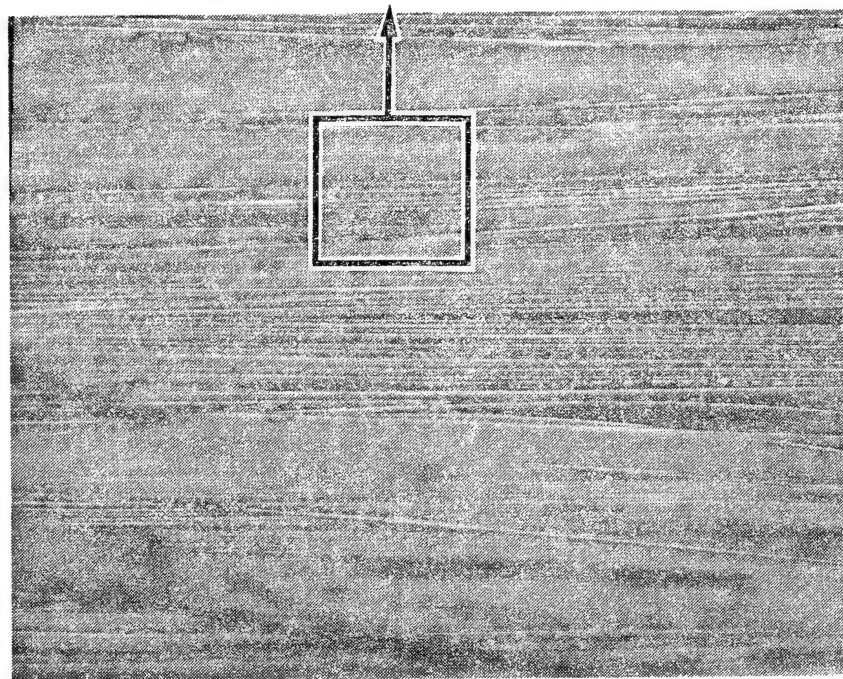
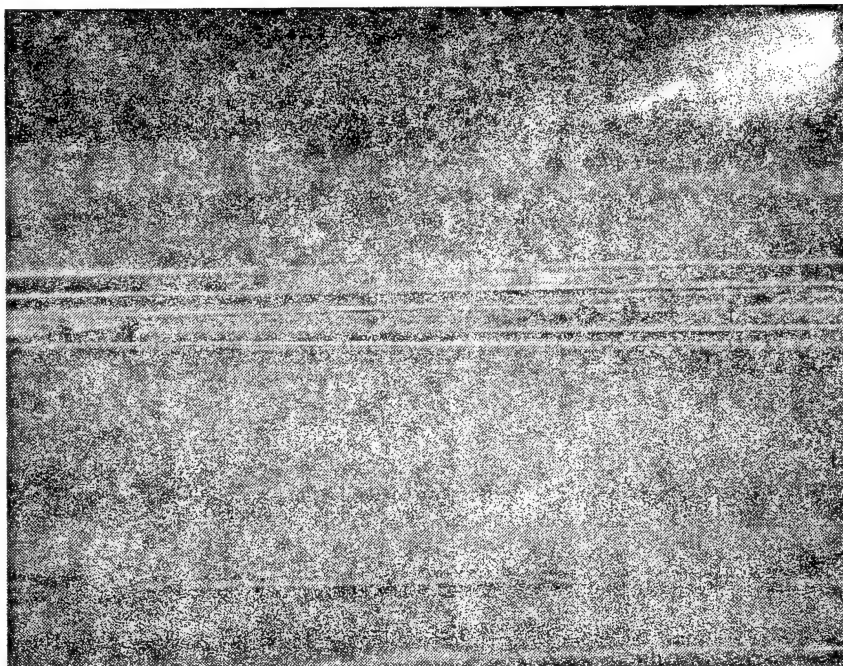
This fracture surface was generally similar to the RT surface but with minor differences such as fibers pulled out from the surface and slightly larger matrix craze filaments (Figures 3.2-3 and 3.2-4).

Figure 3.2-3. Optical Fractography of KII/AS4 Interlaminar Mode I Tension Specimen Tested at 400° F/Dry

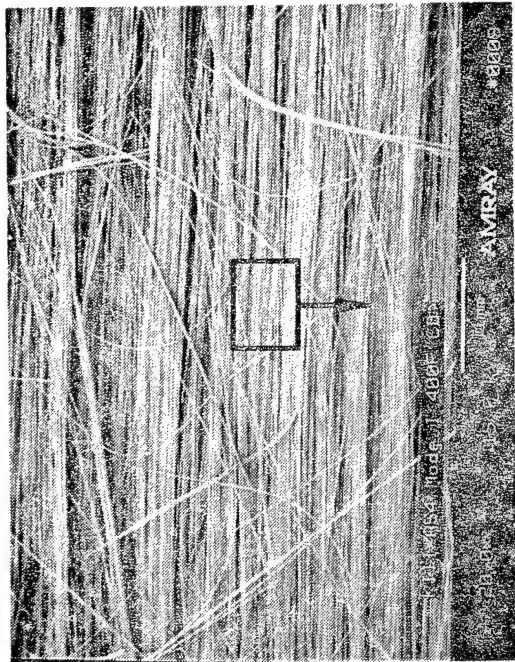
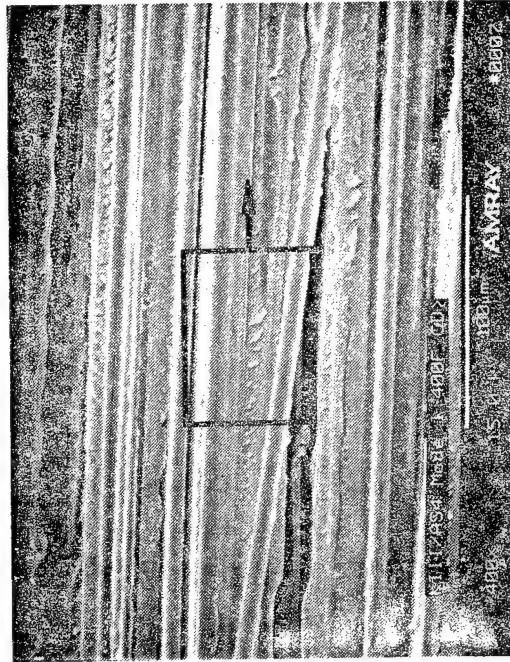
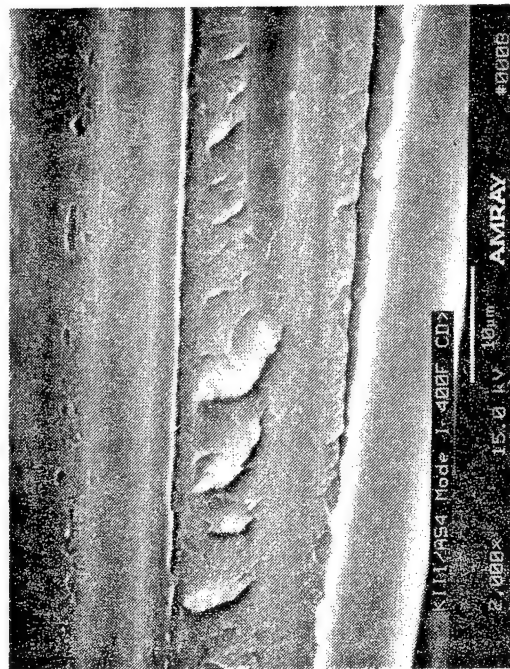
Figure 3.2-4. SEM Fractographs of a K111/AS4 Interlaminar Mode I (Tension) Fracture Surface, 400°F

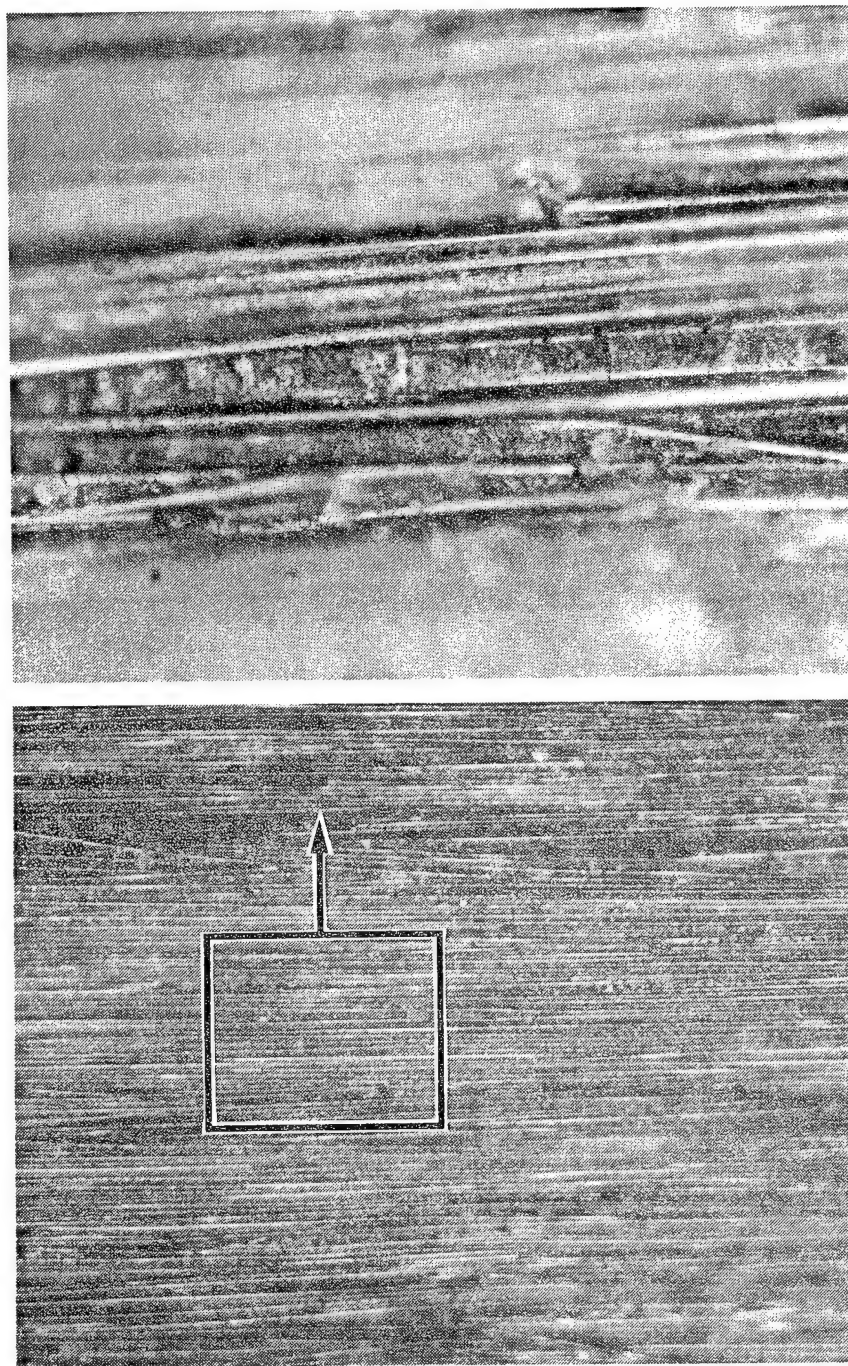
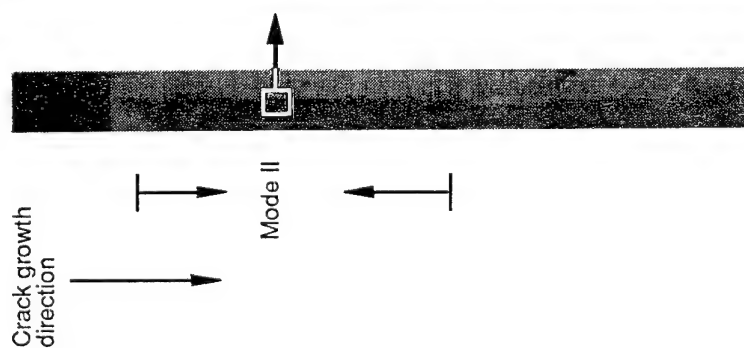
As with the mode I (tensile) case, the mode II (shear) surface morphology exhibited features similar to those of the PEEK specimens, except that there were no loose fibers on the surface. This morphology was also similar to the KIII/AS4 mode I surface, making it difficult to determine the loading condition (Figures 3.2-5 and 3.2-6).

Figure 3.2-5. Optical Fractography of KIII/AS4 Interlaminar Mode II Shear Specimen Tested at RT/Dry

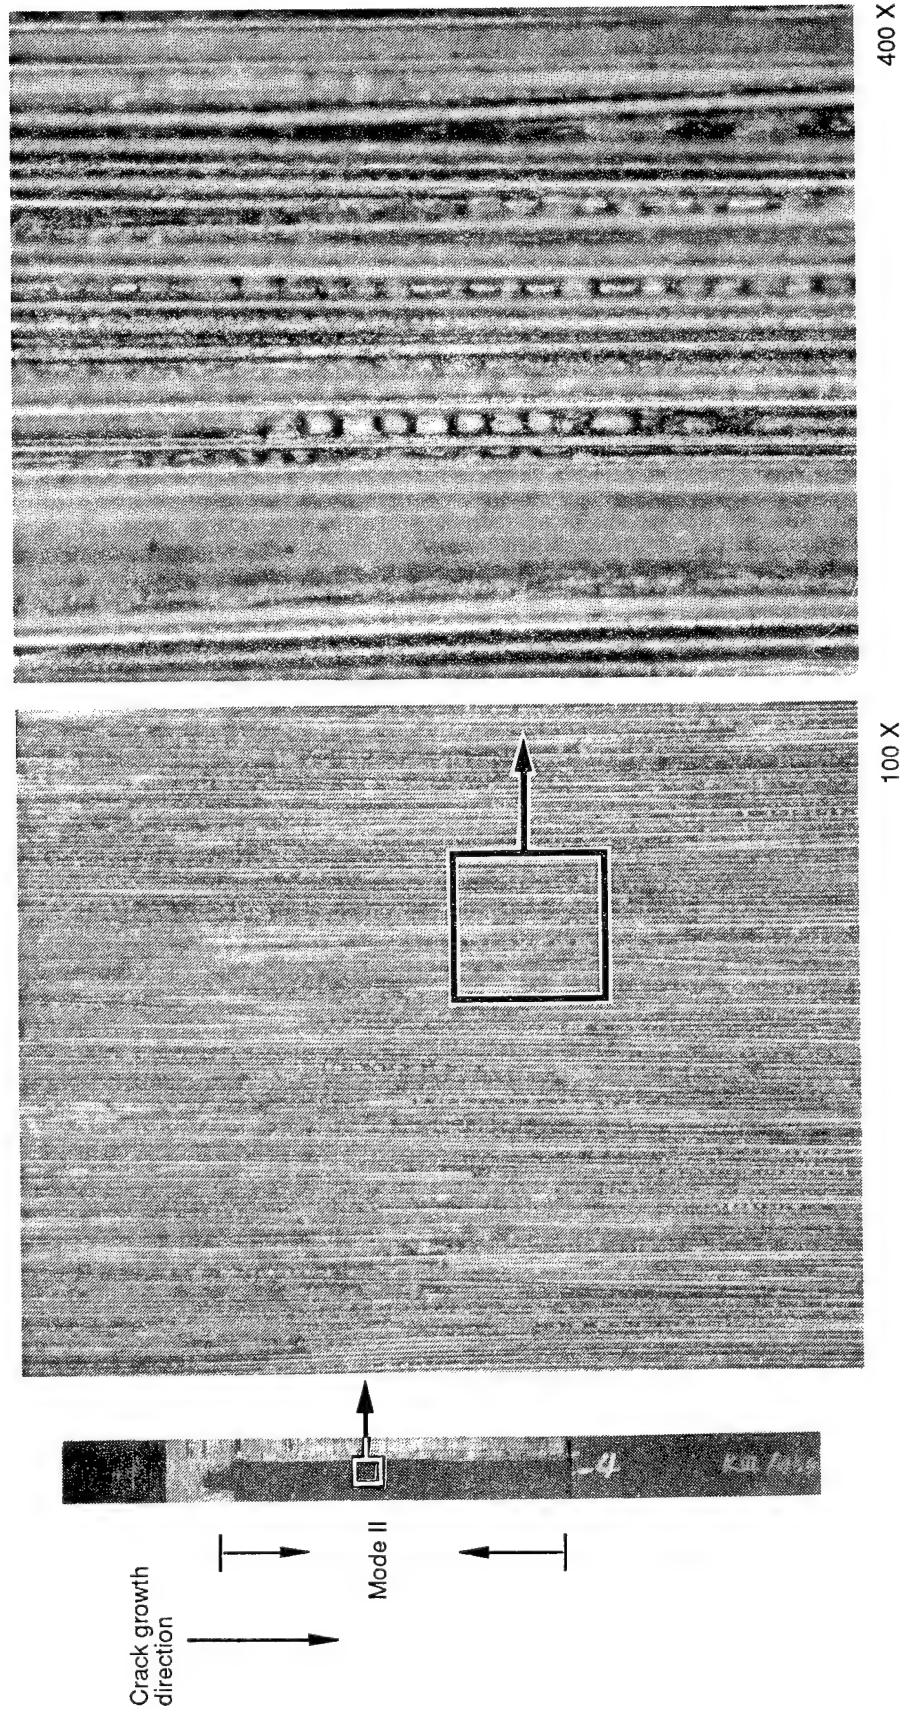
Figure 3.2-7. Optical Fractography of KIII//AS4 Interlaminar Mode II Shear Specimen Tested at 400° F/Dry

There were no significant differences between the fracture morphology of the RT and the elevated temperature test specimens as shown in Figures 3.2-7 and 3.2-8.

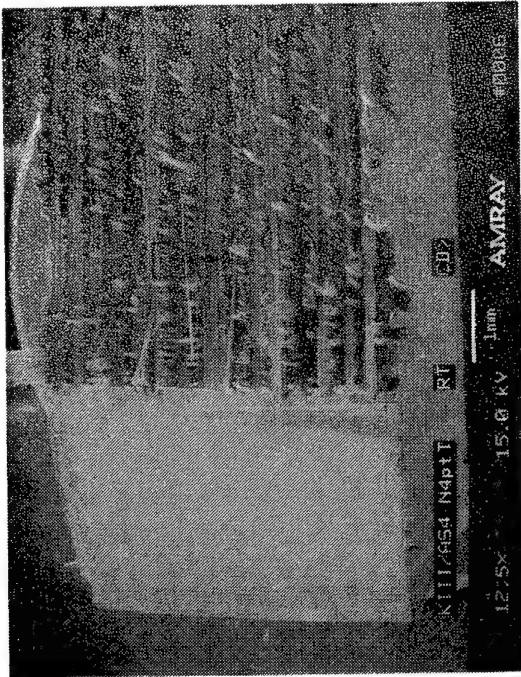
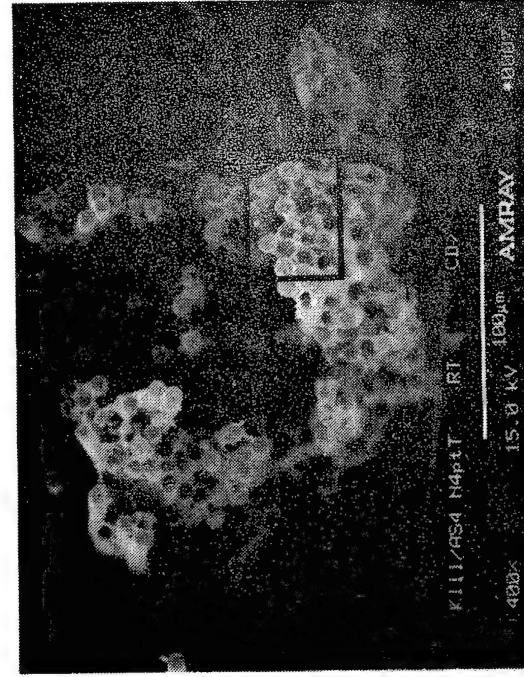
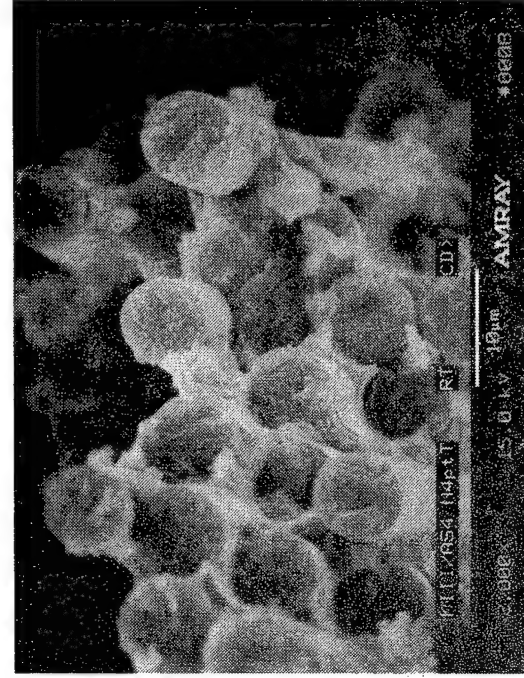
Figure 3.2-9. SEM Fractographs of a KIII/AS4 N4ptT Specimen, Transverse Fracture Surface, Room Temperature

The overall appearance of the room temperature fracture morphology was typical of a notched four-point tensile specimen, exhibiting a very jagged surface. The fracture origins on the fiber ends were easily visible and generally indicated the overall mechanically induced crack direction (Figure 3.2-9). The interlaminar surfaces (Figure 3.2-10) were identical to the mode I fracture morphology as described above.

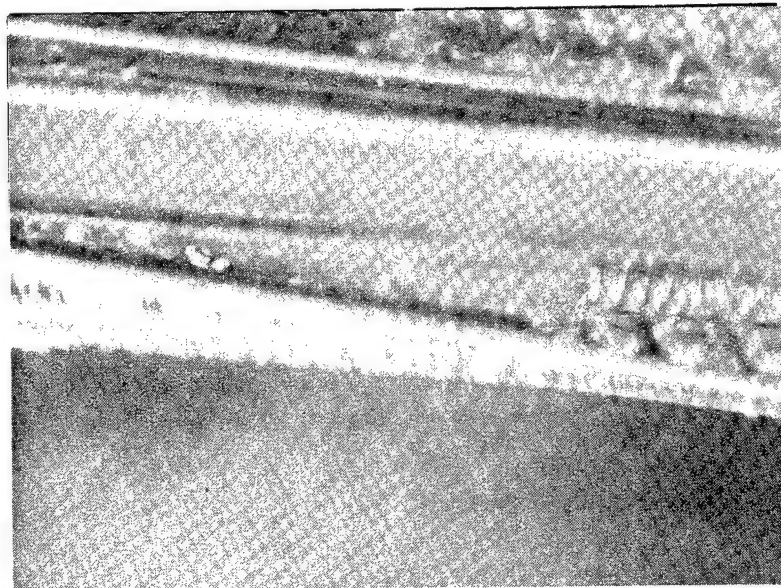
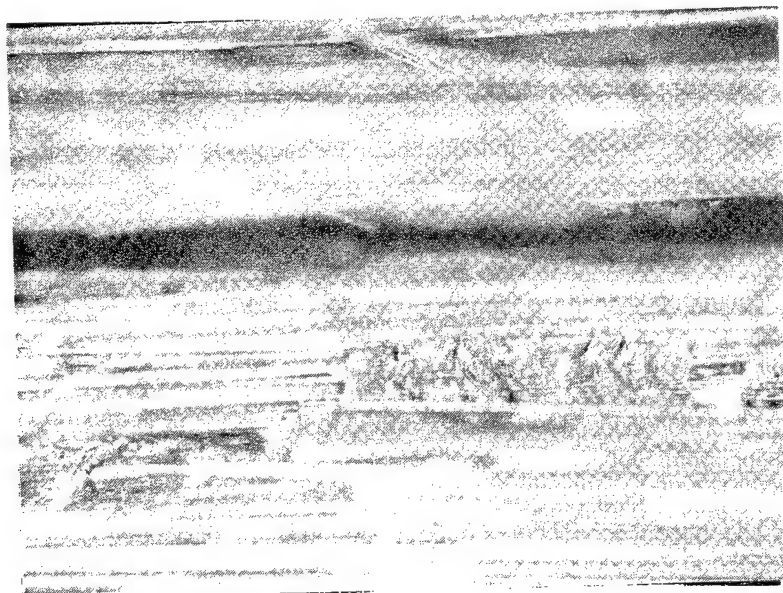
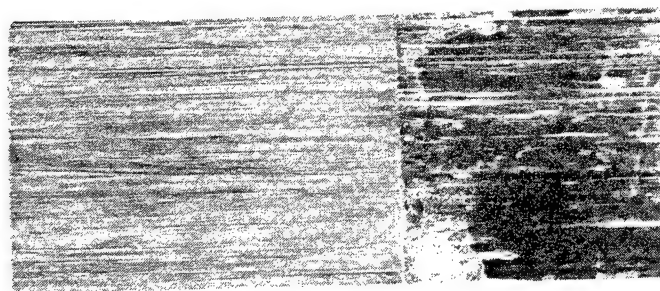
Figure 3.2-11. Optical Fractographs of a KII/AS4 Interlaminar Mode I (Tensile) Fatigue Fracture Surface, RT

Both the RT (Figures 3.2-11 & 3.2-12) and the 350°F tested specimens (Figures 3.2-13 & 3.2-14) exhibited similar fracture features which appeared to resemble a mode II (shear) morphology. The resin material between the fibers contained hackles which indicated the overall crack growth orientation. No rivermarks or other distinctive mode I features were observed.

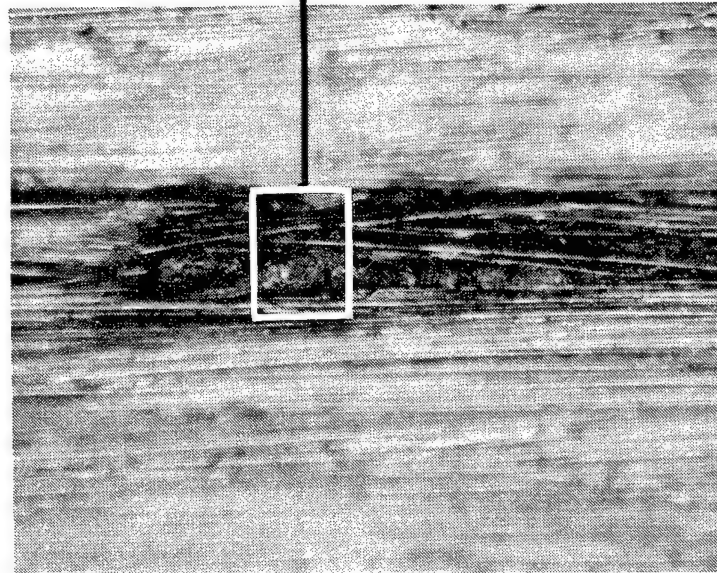
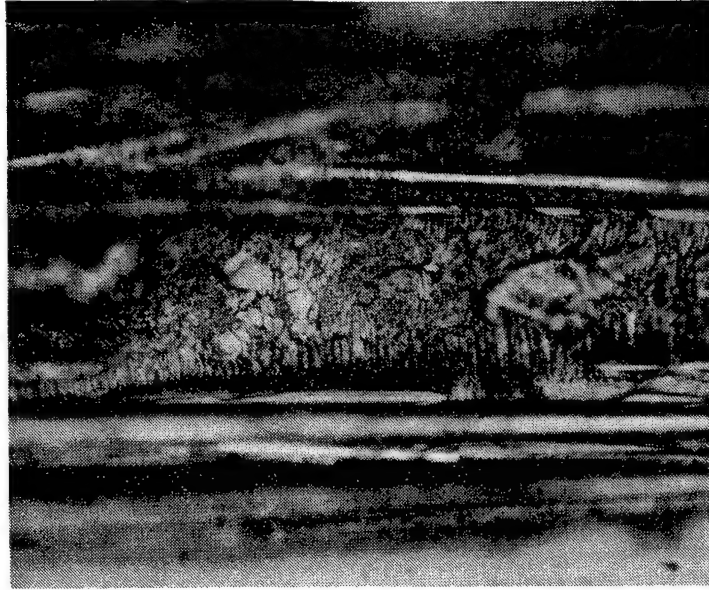
Figure 3.2-15. Optical Fractographs of KIII/AS4 Interlaminar Mode II (Shear) Fatigue, Room Temperature, High Stress

Examination of the fracture surfaces did not reveal any definite indications of fatigue, except for a feature that may be related to the cyclic loading. This feature appeared to be typical of a mode II hackle. However, when observed at high magnification the feature appears to be wider and thinner than similar hackles on statically loaded specimens. This feature was observed both on the RT specimen (Figures 3.2-15 and 3.2-16) and the 350°F tested specimens (Figures 3.2-17 and 3.2-18).

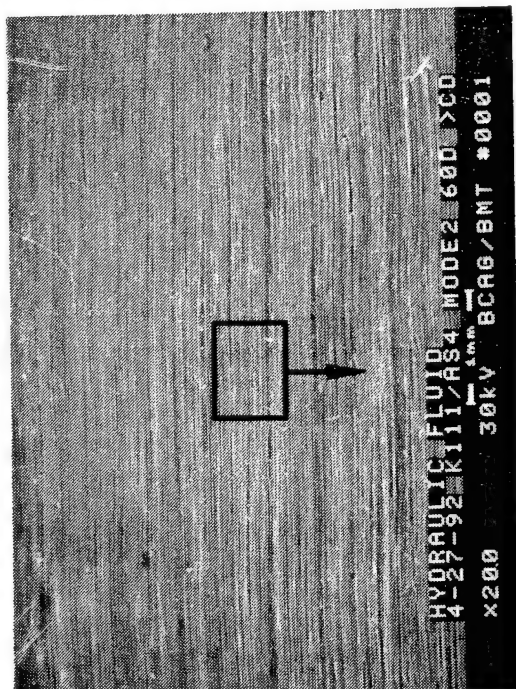
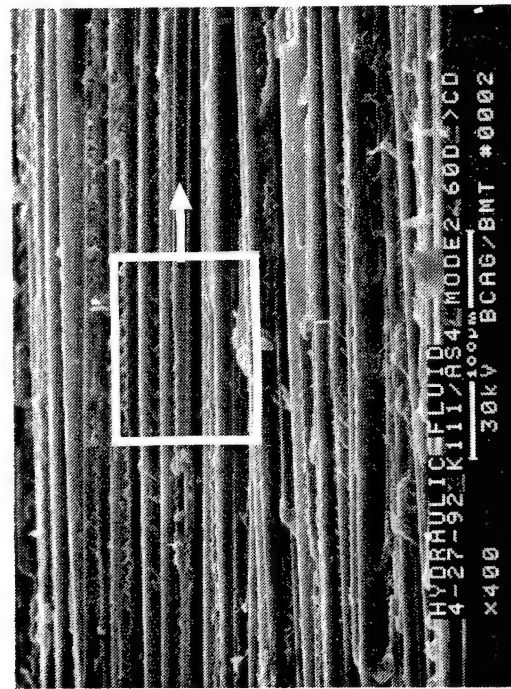
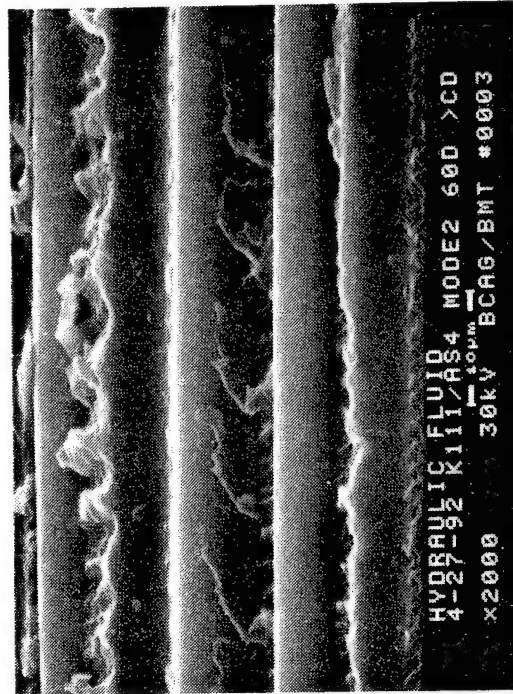
Figure 3.2-19. SEM Fractographs of a K111/AS4 Interlaminar Mode II Shear Fracture Surface Exposed to Hydraulic Fluid for 7 Days

Examination of the mode II surfaces (Figure 3.2-19 through Figure 3.2-25) exposed to the various environments revealed that the hydraulic fluid (Figure 3.2-19) and JP4 jet fuel (Figure 3.2-20) slightly degraded the fracture features. The fibers appeared to be "cleaner" when compared to the control specimens. However, this did not alter the surface morphology enough to prevent identification of the mode II fracture features, such as the cusp and matrix filaments.

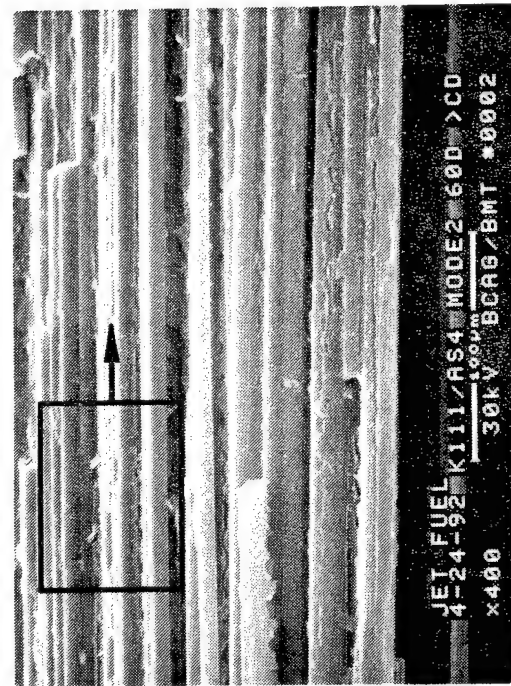
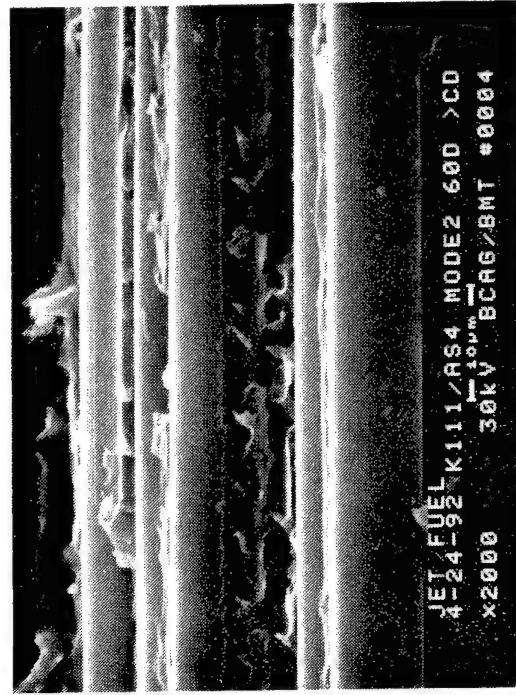
Figure 3.2-20. SEM Fractographs of a K111/AS4 Interlaminar Mode II Shear Fracture Surface Exposed to JP4 Jet Fuel for 7 Days

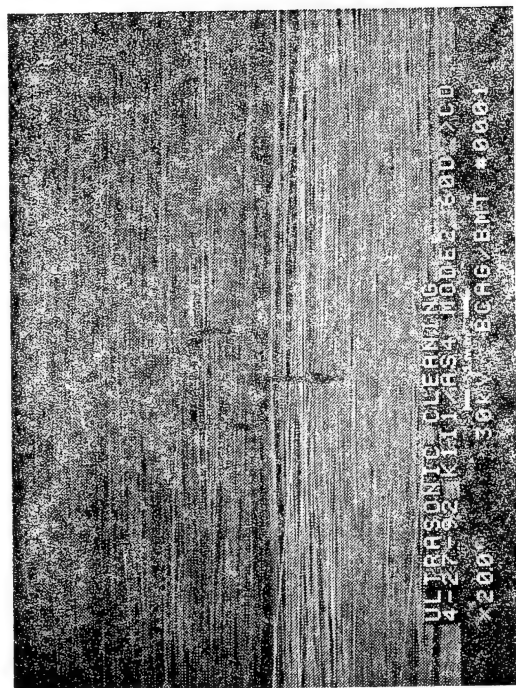
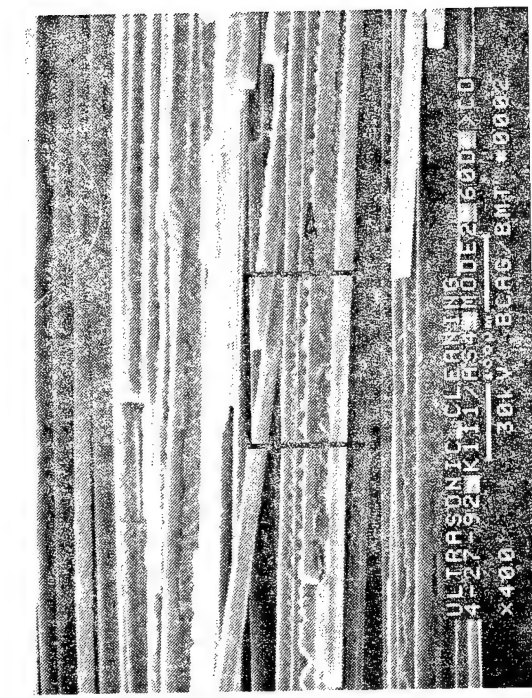
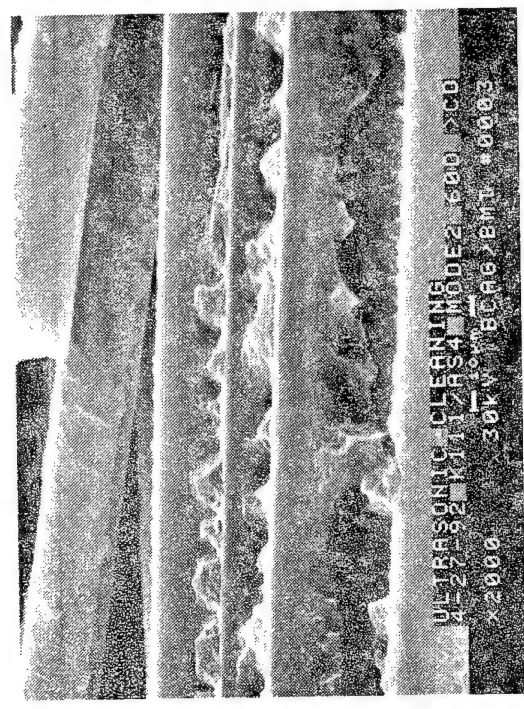
Figure 3.2-21. SEM Fractographs of a K111/AS4 Interlaminar Mode II Shear Fracture Surface Exposed to Ultrasonic Agitation in Distilled Water for 24 Hours  
2405.01 9-5576 D1ai
